Belen Recreation Park Drainage

Drainage Engineering

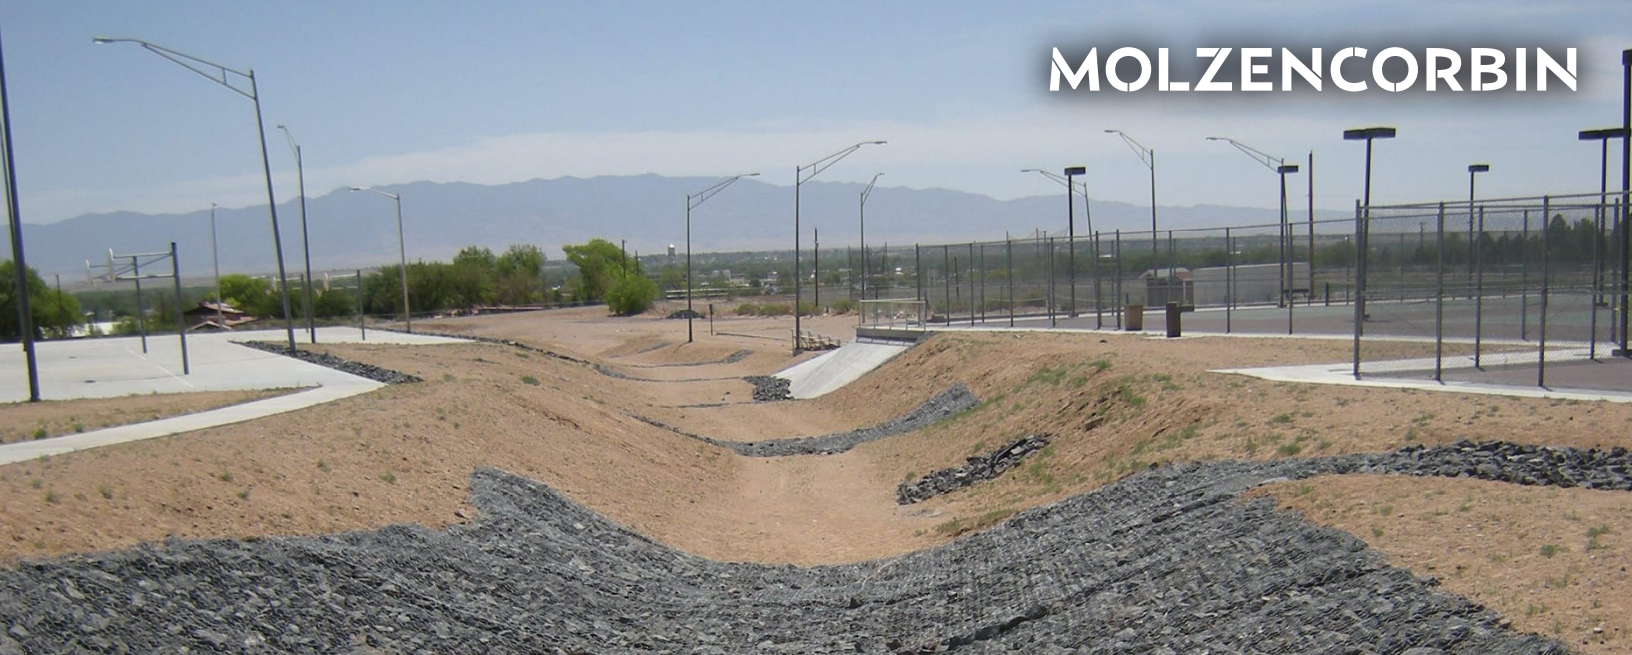
This project restored damaged areas caused by extreme rainfall events and included grading of the channel and installation of grade control structures and rip-rap armor to protect strategic channel locations. Located in an urban recreation park, the channel was designed and constructed with an equilibrium slope to properly route future rainfall events and to dissipate the energy of the water with a “stair step” concept.
